Delivery Order 9 Enhanced Preliminary Assessment

FORT DEVENS, MASSACHUSETTS

April 1992

ENHANCED PRELIMINARY ASSESSMENT

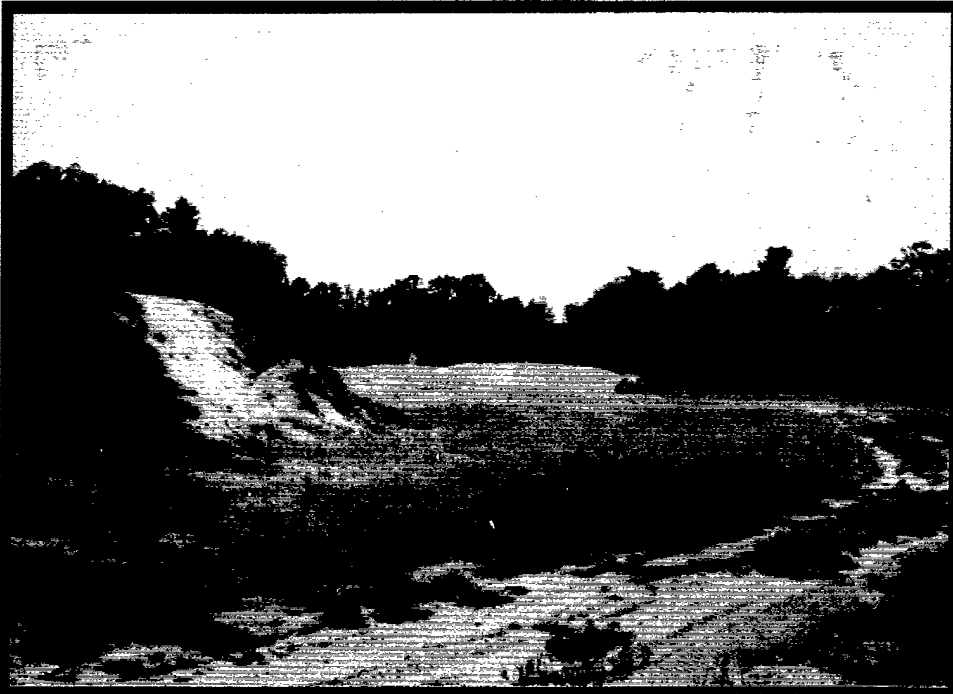
3. AREE 5 - SHEPLEY'S HILL LANDFILL (NO.1)

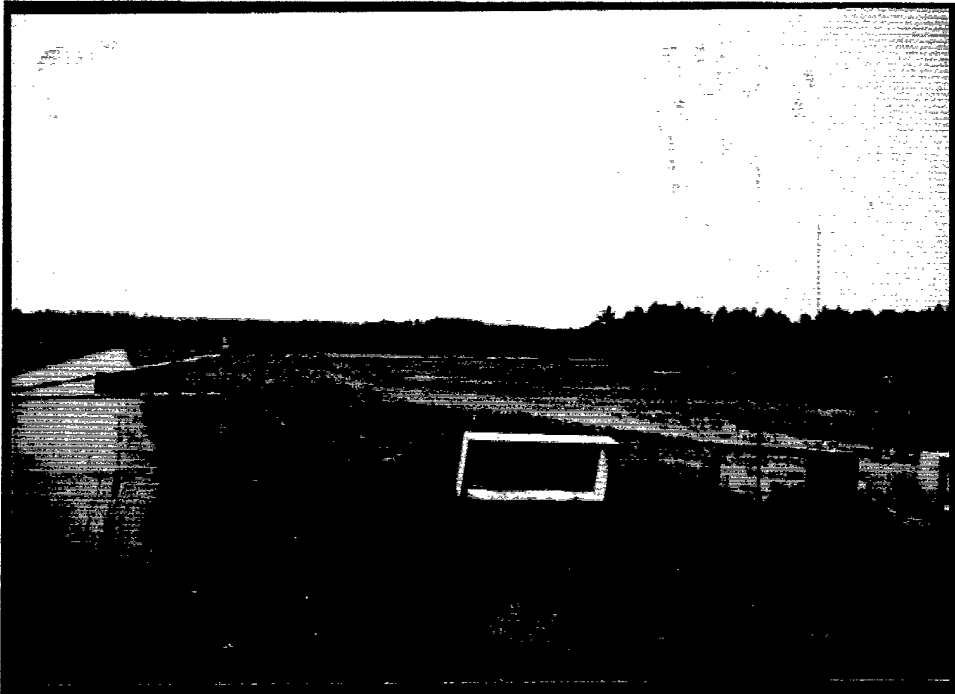
5. AREE 14 - FORMER QUARRY AS LANDFILL NO. 10

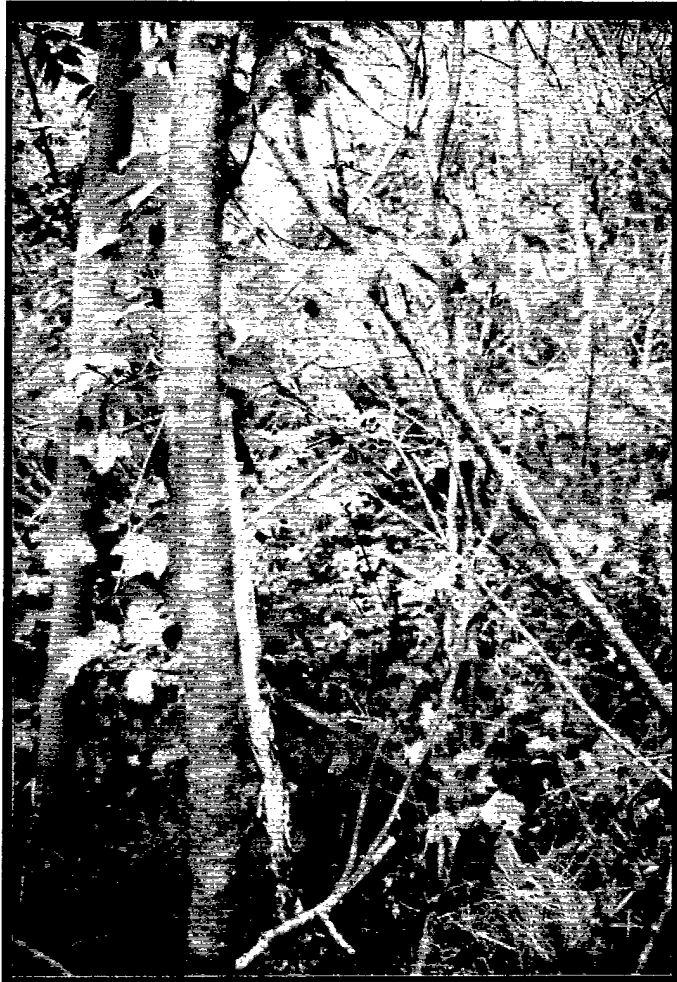
7. AREE 16 - GENERAL CONDITIONS AT LANDFILL NO. 12

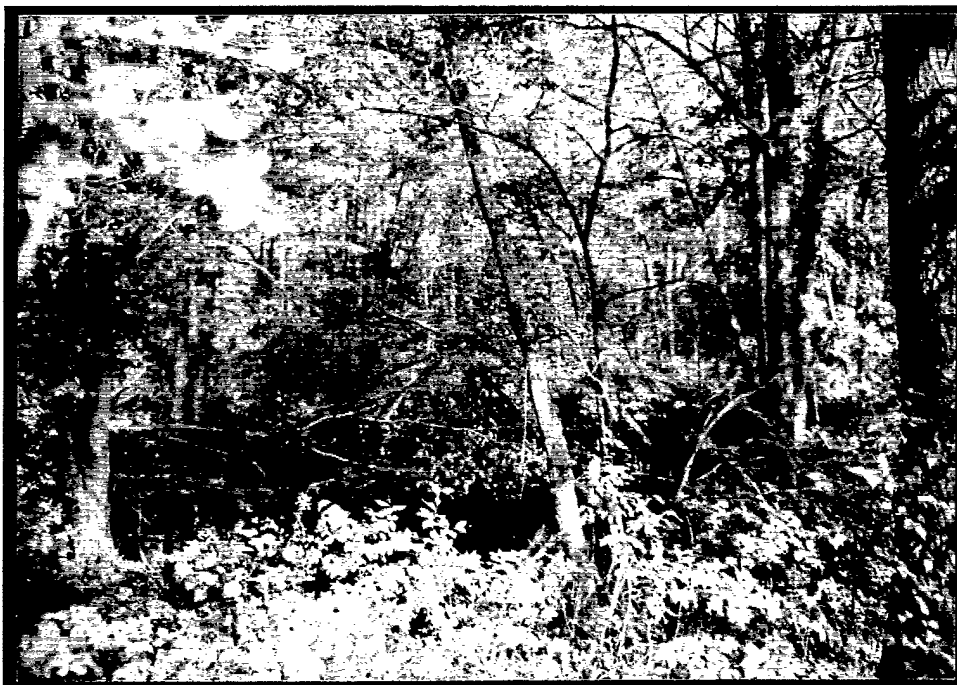
**8. AREE 40 - GENERAL CONDITIONS AT
COLD SPRING BROOK LANDFILL**

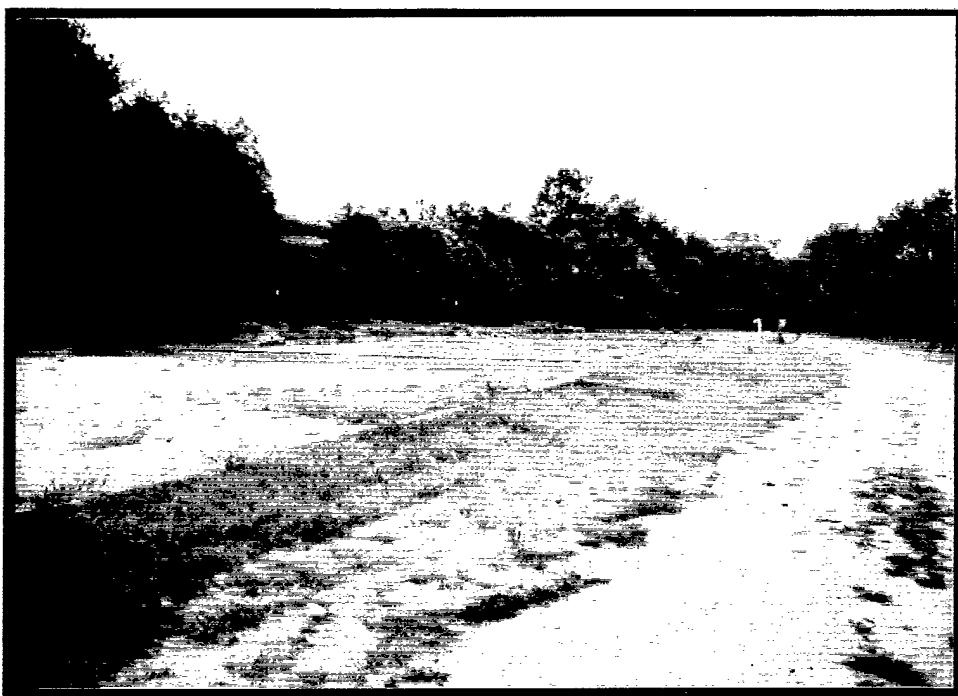
11. AREE 20 - TYPICAL RAPID INFILTRATION BASIN

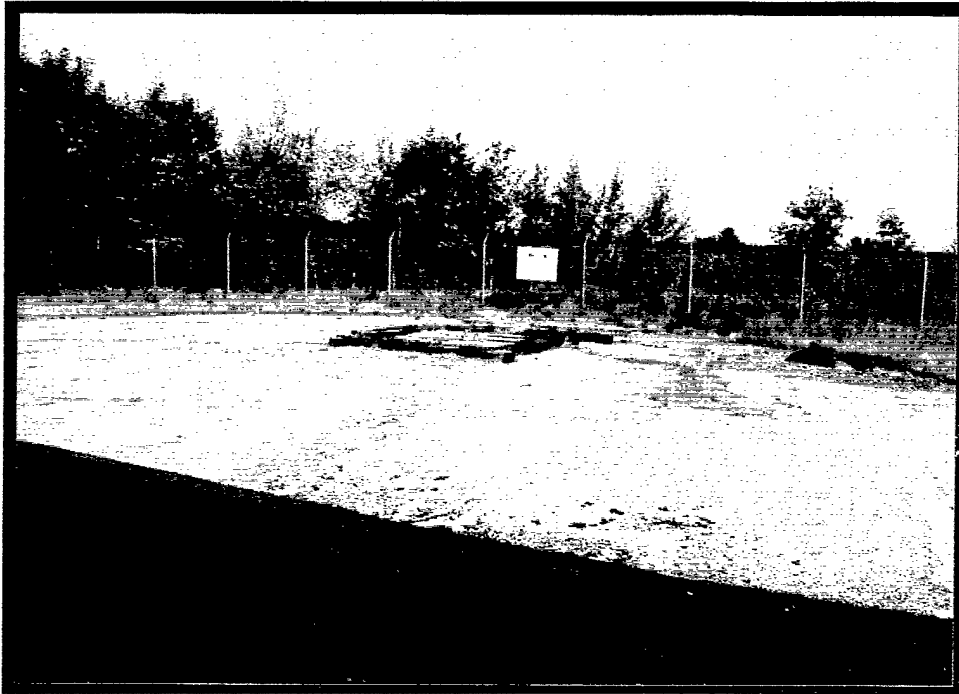
**13. AREE 22 - DRUMS LOCATED BEHIND HAZARDOUS WASTE
STORAGE FACILITY (BUILDING 1650)**

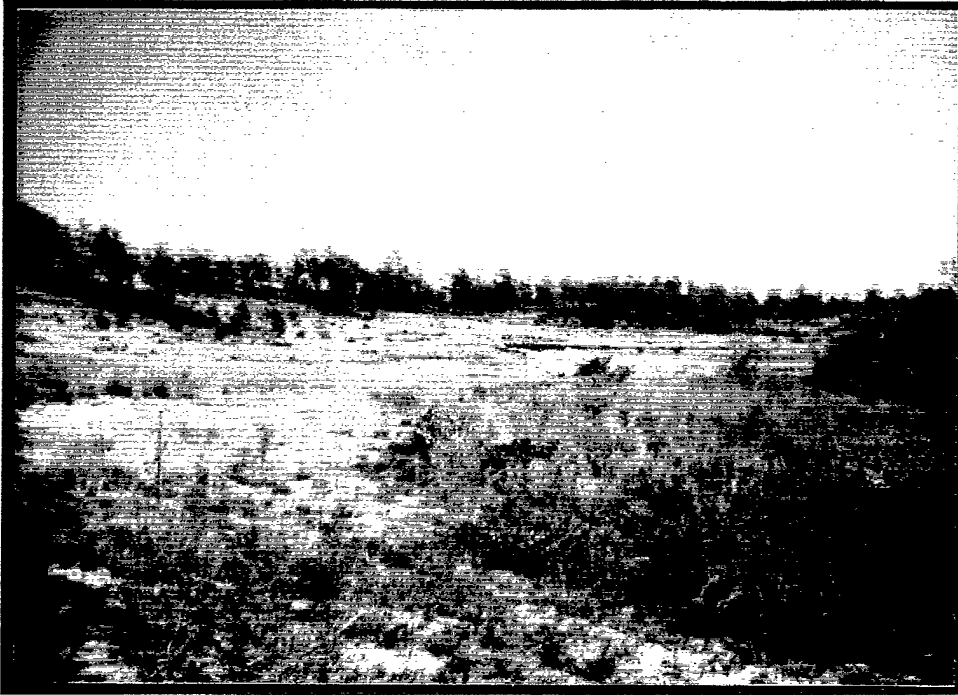
15. AREE 25 - TYPICAL CONDITIONS AT EOD RANGE

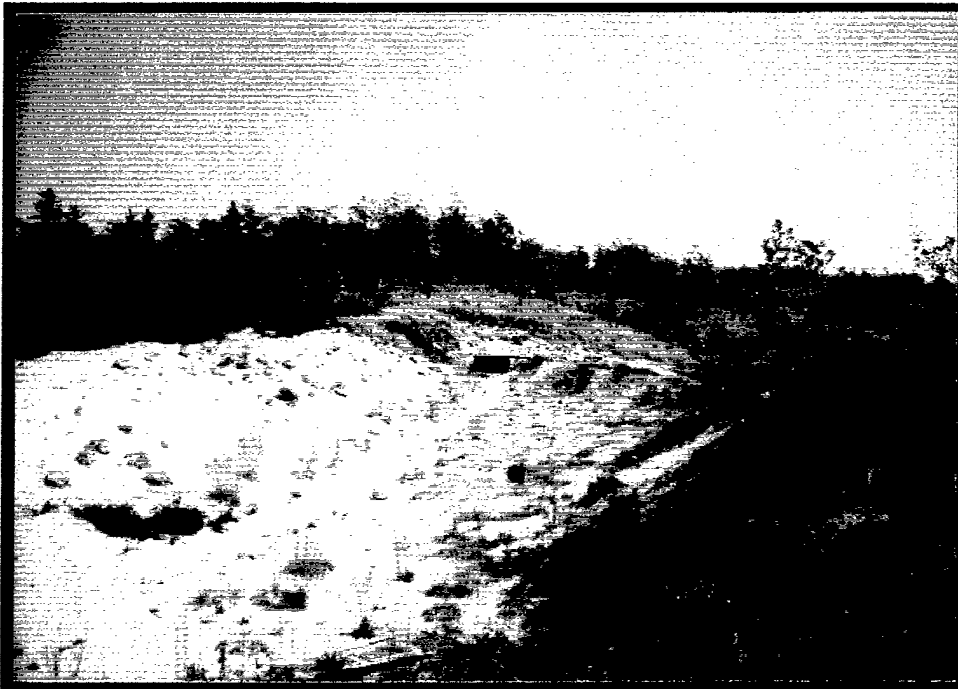
16. AREE 26 - TYPICAL CONDITIONS AT ZULU I RANGE

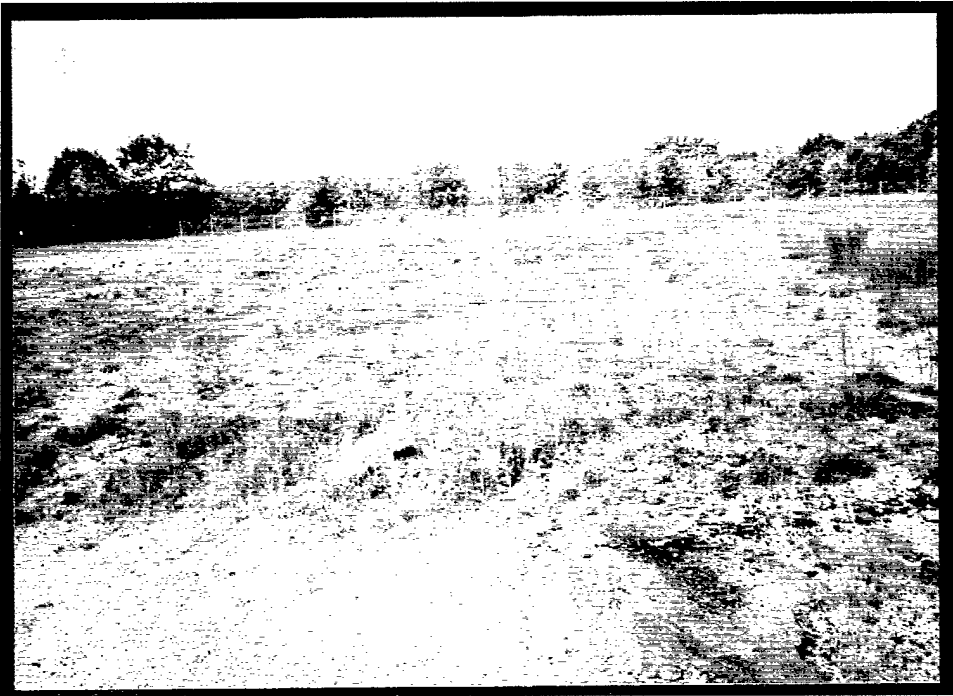
17. AREE 26 - TYPICAL CONDITIONS AT ZULU II RANGE

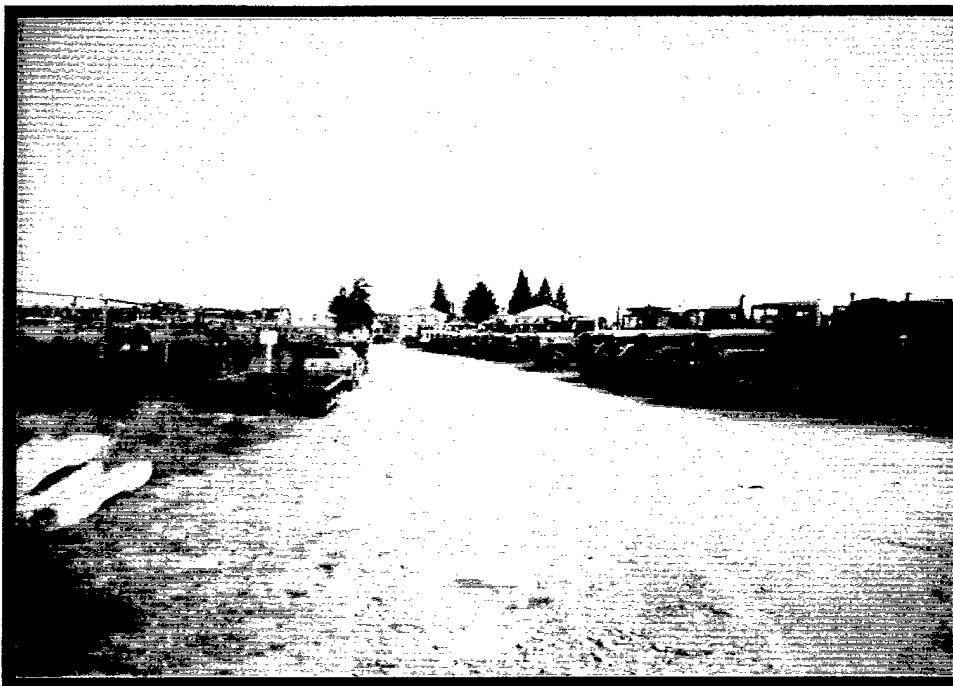
21. AREE 52 - GENERAL CONDITIONS AT THE TDA MAINTENANCE YARD

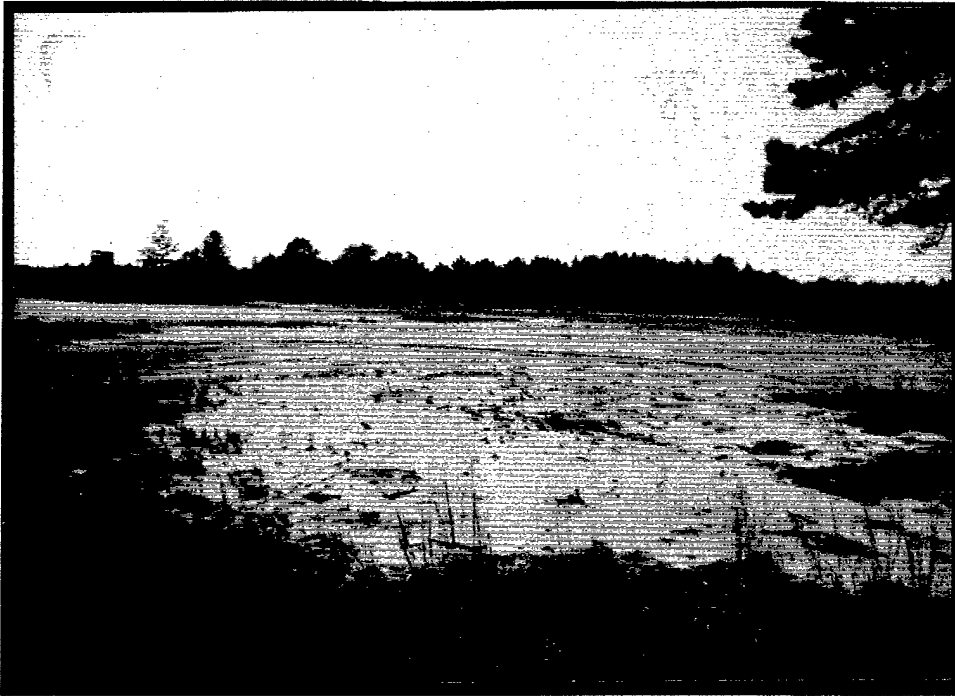
22. AREE 53 - CURRENT CONDITIONS AT TYPICAL POL SPILL SITE

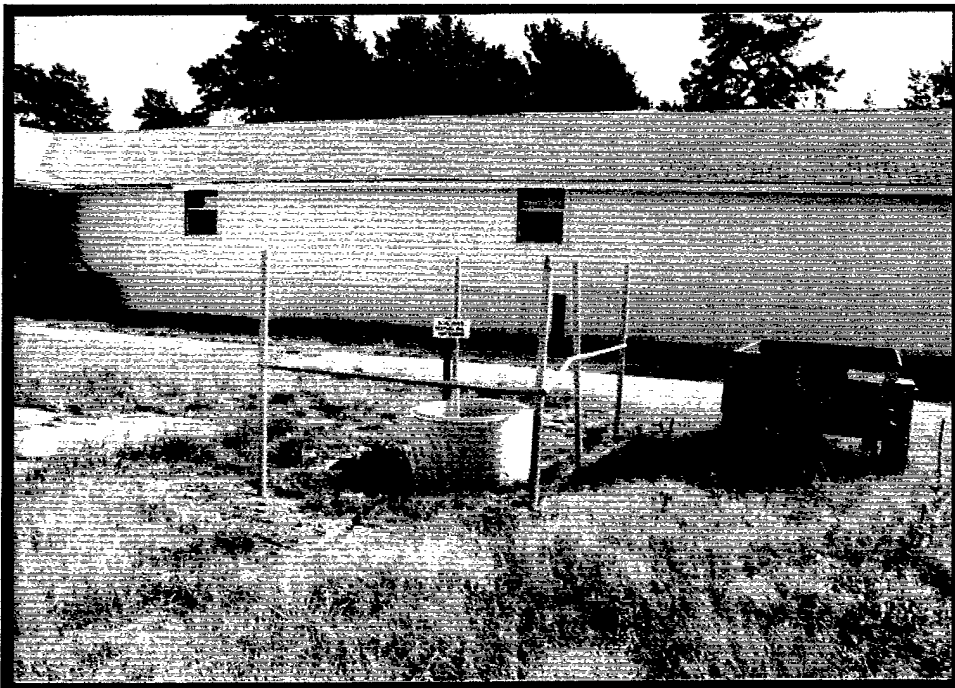
23. AREE 61 - CURRENT CONDITIONS AT TYPICAL UST
